NSA-111paw
96V-129

Re: Toyota Tacoma Front Suspension
Part 573, Defect Information Report

DEFECT INFORMATION REPORT

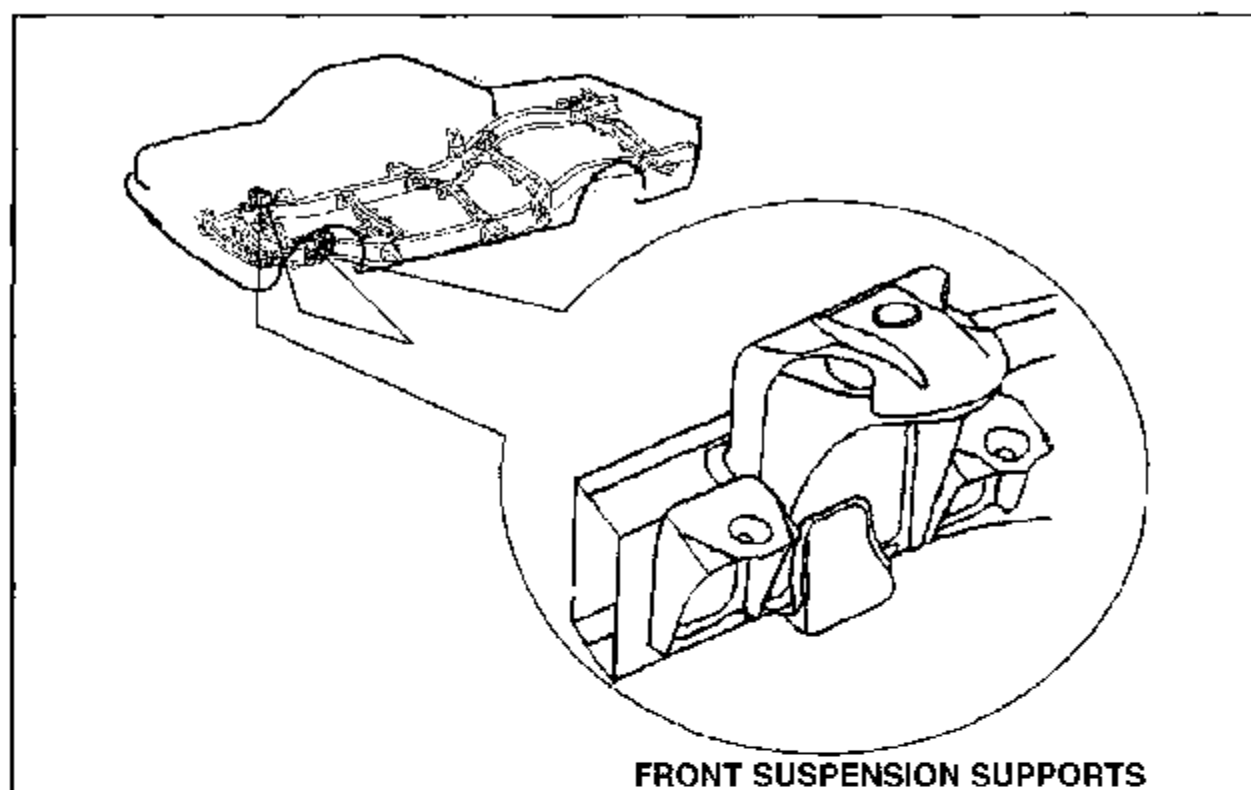
3. LOCATION OF INVOLVED PARTS

If the front suspension of the subject vehicle is repeatedly exposed to simultaneous up-and-down and back-and-forth motions, e.g. driving over "speed bumps" under severe braking, the front suspension support may crack, which could ultimately lead to failure of the support. This could result in the loss of vehicle control.

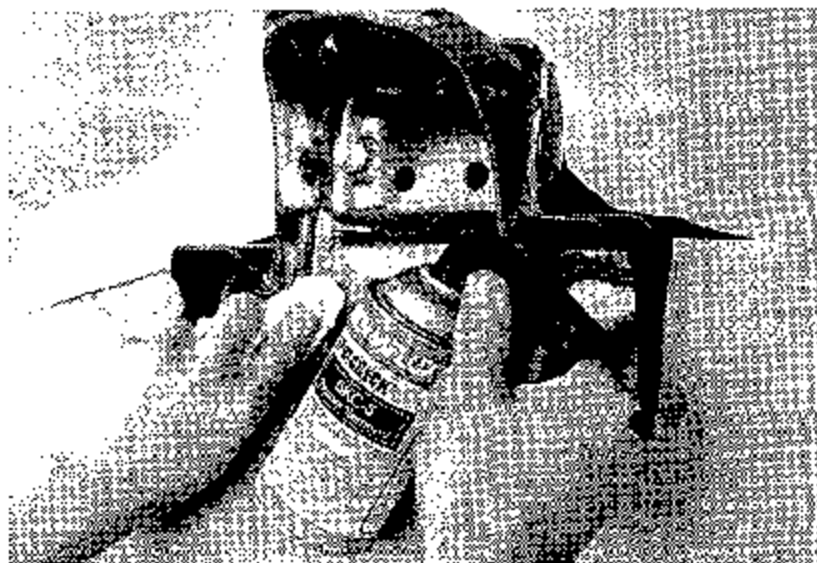
5. Inspect for cracks

Cracks will be marked by a deep red indicator mark.

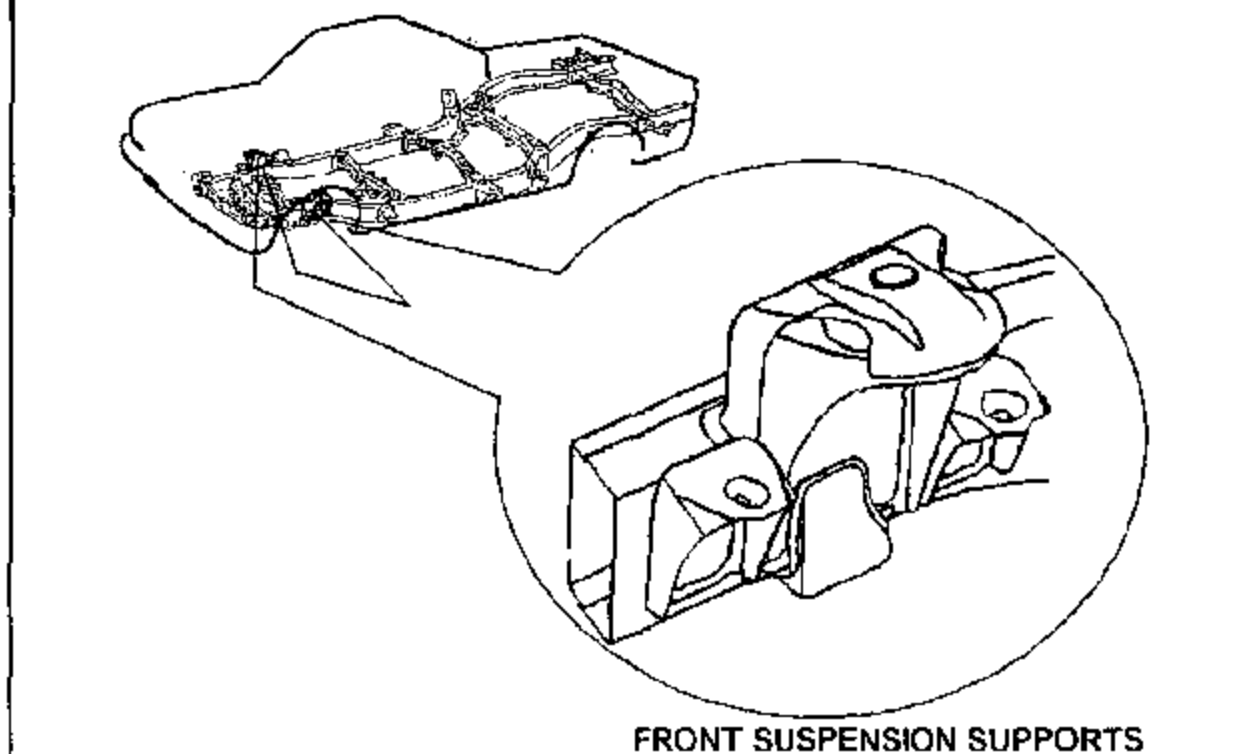
Diagram 3

(Area to be inspected)

1. Inspect only **Customer** vehicles, if requested by the customer, which you have determined to be involved in SSC T06 using the preceding steps. **Federal Regulation requires that IN-STOCK VEHICLES be REPAIRED prior to delivery.**
2. Raise the vehicle on a hoist.
3. Remove both front wheels.
Locate the front suspension supports
[See Diagram 3]

4. Carefully conduct a visual inspection of the areas indicated (both driver and passenger sides) for any signs of cracking.
[See Diagram 4]
5. If there are no signs of cracking of the suspension support, the vehicle should be operated until the owner notification occurs and the vehicle is repaired.

If a vehicle is found to have any cracking of the suspension support, it must be physically inspected by a Regional Service Representative and if confirmed, further arrangements will be made through the Regional Customer Relations Department.

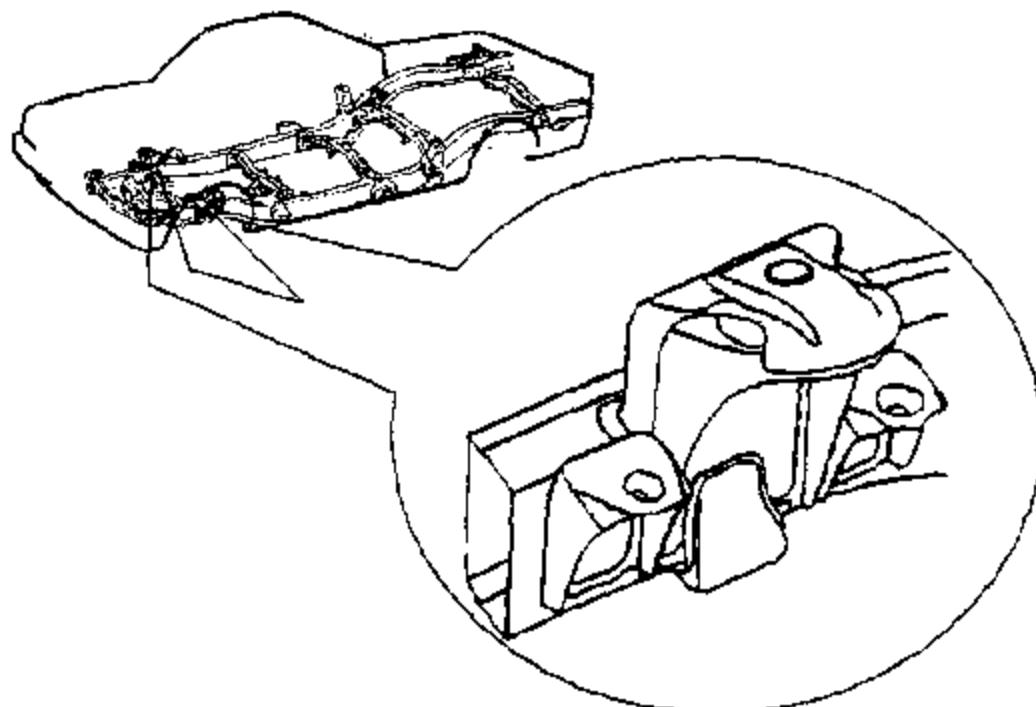
Diagram 3

(Area to be inspected)

FRONT SUSPENSION SUPPORTS

1. Inspect only **Customer** vehicles, if requested by the customer, which you have determined to be involved in SSC T06 using the preceding steps. **Federal Regulation requires that IN-STOCK VEHICLES be REPAIRED prior to delivery.**
2. Raise the vehicle on a hoist.
3. Remove both front wheels.
Locate the front suspension supports
[See Diagram 3]

4. Carefully conduct a visual inspection of the areas indicated (both driver and passenger sides) for any signs of cracking.
[See Diagram 4]
5. If there are no signs of cracking of the suspension support, the vehicle should be operated until the owner notification occurs and the vehicle is repaired.

If a vehicle is found to have any cracking of the suspension support, it must be physically inspected by a Regional Service Representative and if confirmed, further arrangements will be made through the Regional Customer Relations Department.
